## AIRCRAFT CARRIER EXPOSURE TESTS OF ALUMINUM ALLOYS

E. J. Jankowsky, S. J. Ketcham and V. S. Agarwala  
Aircraft and Crew Systems Technology Directorate  
NAVAL AIR DEVELOPMENT CENTER  
Warminster, Pennsylvania 18974

1 NOVEMBER 1979

PROGRESS REPORT  
AIRTASK NO. ZF61-542-001  
Work Unit No. ZM501

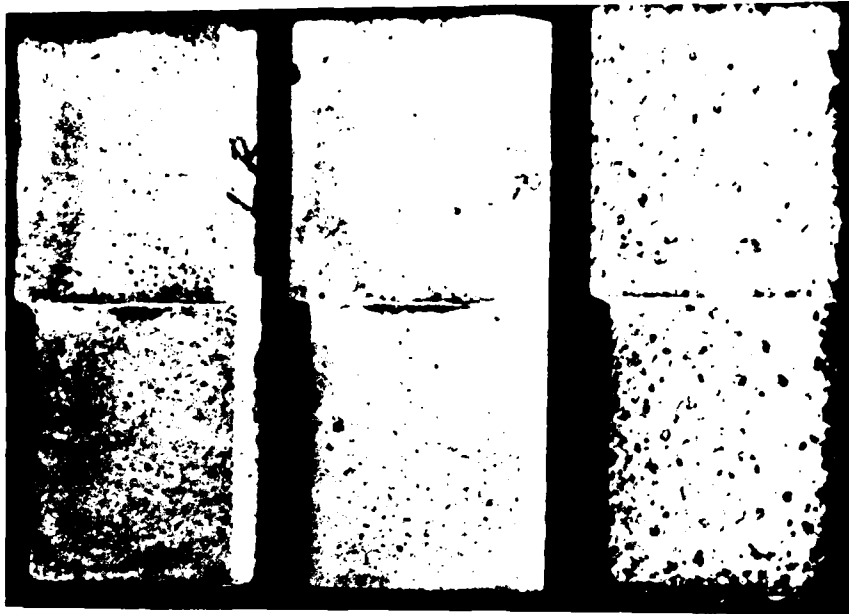
Figure 10 - Results of Salt Spray Tests On 2124 - 1/2 in. Plate - 37 Days.

Results of salt spray tests are given in table III. Appearance of the panels is shown in figures 9 to 13. Comparison with figures 4 to 8 clearly show a difference. The panels exposed on the carrier lack the general or surface attack that occurred on the salt spray panels. On the carrier panels, exfoliation attack initiated at the machined edges and essentially undermined the surface. The distinct layering that occurred on the carrier samples did not occur on the salt spray panels although exfoliation attack is present on low and medium resistance tempers.
